Navajo Abandoned Uranium Mine

Site Screen Report

Knife Edge Mesa AUM Site

March 2010

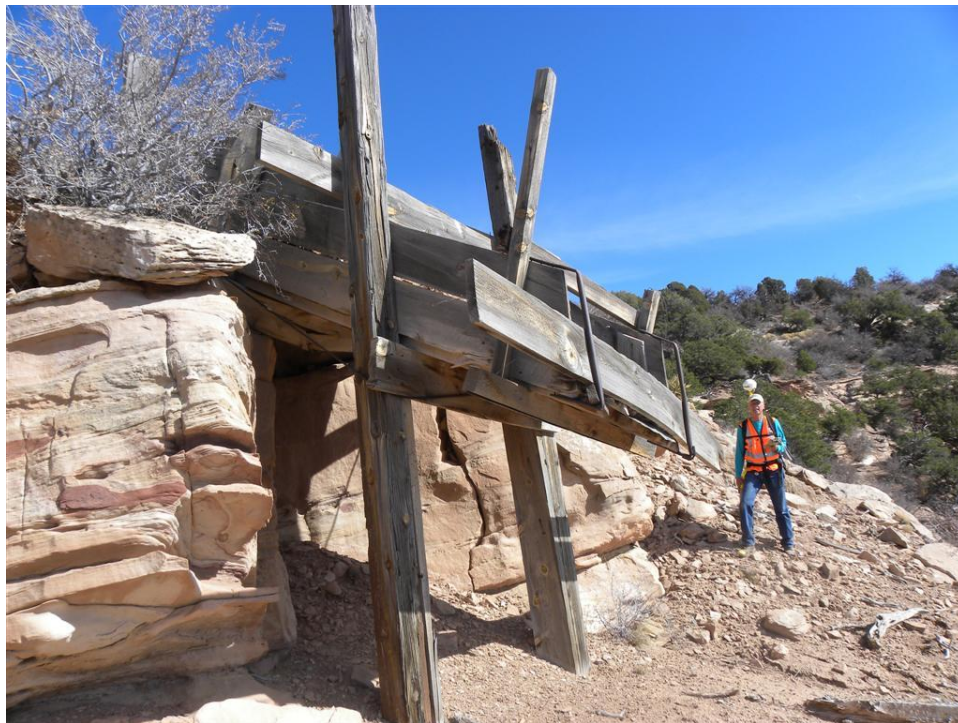
Various mining debris, pipes, wood framed chute

Photo 3. Wood framed chute

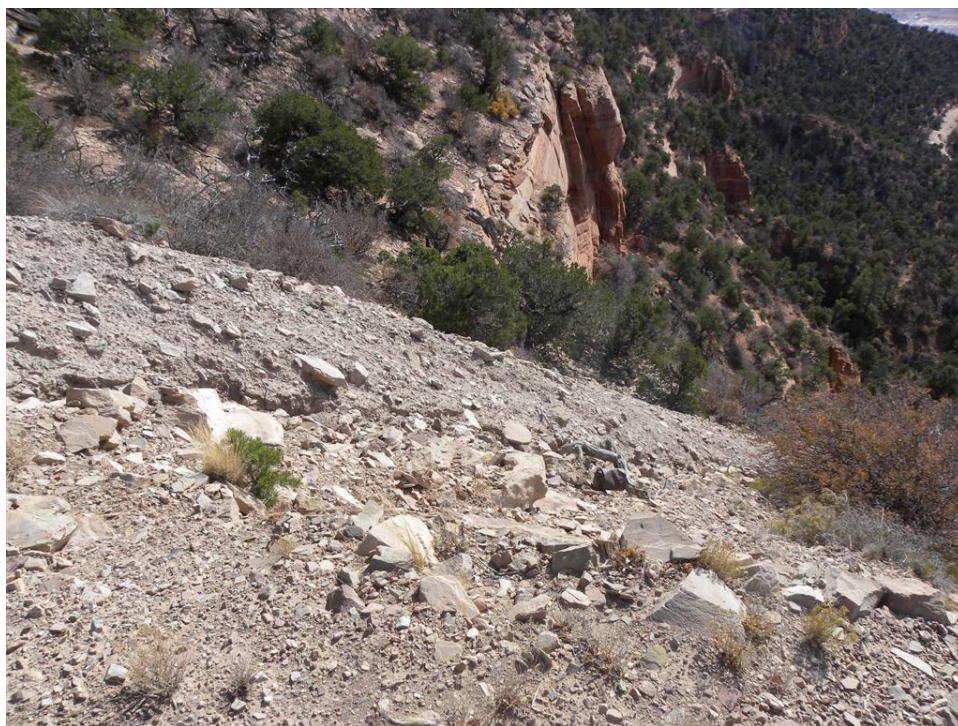
Waste debris stretching down cliff 50' x 125', with a total estimated volume of 1,157 yd³

Photo 4. Waste pile heading down slope

Unreclaimed waste pile

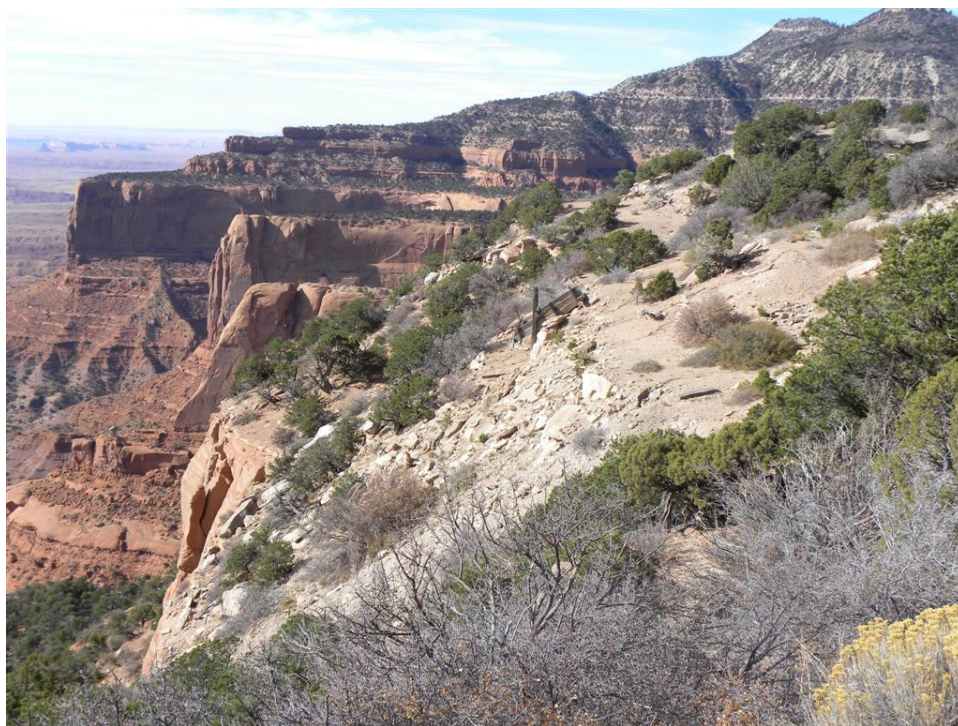
Photo 5. Waste pile heading down slope
